# CASE STUDY – *London Coliseum*

English National Opera

Stonewest Limited

- **Date:** 2002-2003

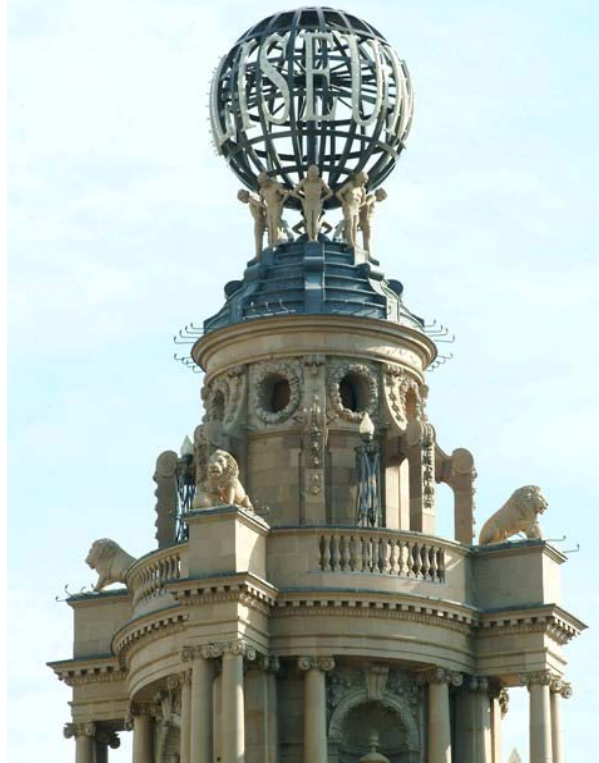
Stonewest prepared a schedule of works based on a scaffold inspection, followed by trial cleaning and paint removal and structural investigations.

- All façades were paint stripped to expose structural damage and assumed post war damage that had resulted in major areas to corners being filled with concrete.

- Several thousand new damaged terracotta blocks were carefully cut out and replaced with new build.
- Structural secondary steels had corroded beyond their useful life and were contributing to the fracturing of terracotta. A complete section of the tower was temporarily 'jacked' to allow replacement of this steelwork; this also entailed a complete rebuild of the decorative terracotta and the backing brickwork.

- New terracotta was sourced using traditional fired blocks designed to replicate the original to include a dragged tool finish.
- Management of the terracotta manufacture was a continuous process, integral to the project.

- New lead coverings to all main cornices and string courses were installed to appropriate falls with separate flashings.
- At high level around the globe, the decorative supporting statues were missing; this required the design of sculpted maquettes at 1/8th scale for client approval prior to the production of the full sized version.
